Manhole Inspection Summary

Manhole # S27C__023MH

Insp Date: **12/10/07 1:24 PM**

Location Address: **900 FRANKLIN ST**

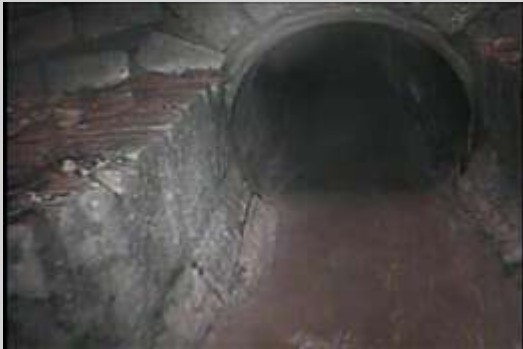
12 O'Clock Outflow

12 in. Circular Gravity Sewer
Pipe Out @ 12 O'Clock

Pipe Height: **12** (in.) Rod and Bar (Angled)
Pipe Material: **Clay** ☐ Pipe Lined
Invert Depth: **15.76** (ft.) Flow Characteristics: **Slow**
Deposits: ☒ None ☐ Mud ☐ Sludge ☐ Debris ☐ Grease
Silt Depth: (in.) Deposits Extent:
Infiltration: **None** Pipe Seal Cond: **Sound**

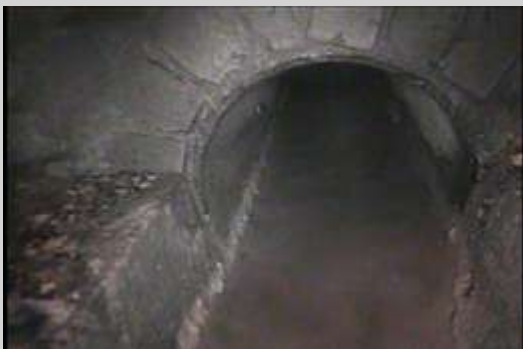
4 O'Clock Inflow

10 in. Circular Gravity Sewer
Pipe In @ 4 O'Clock

Pipe Height: **9.6** (in.) Rod and Bar (Angled)
Pipe Material: **Clay** ☐ Pipe Lined
Invert Depth: **15.36** (ft.) Flow Characteristics: **Slow**
Deposits: ☒ None ☐ Mud ☐ Sludge ☐ Debris ☐ Grease
Silt Depth: (in.) Deposits Extent:
Infiltration: **None** Pipe Seal Cond: **Sound**

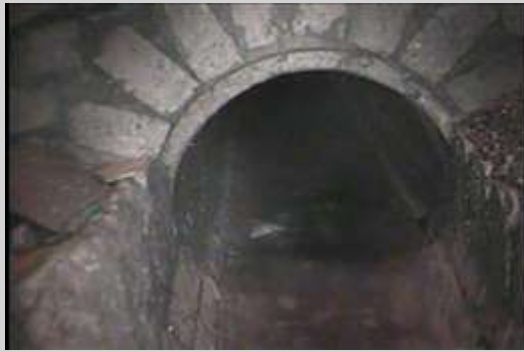
6 O'Clock Inflow

12 in. Circular Gravity Sewer

Pipe In @ 6 O'Clock

Pipe Height: **12** (in.) Rod and Bar (Angled)

Pipe Material: **Clay** ☐ Pipe Lined

Infiltration: **None** Pipe Seal Cond: **Sound**
